## **FIELD INSPECTION REPORT**

Project Name:	Mountain Valley Pipeline	Inspector:	Matthew Grant
Inspection Date:	Wednesday, July 15, 2020	Project Contact:	Brian Clauto
Spread H: Montgomery	MP228.5-227.5 AR 270, 268.01 ATWS 473, 474	Weather:	Dry
ACTIVE STAG	E OF CONSTRUCTION: (Check all that	apply)	
☐ Tree Felling	☐ Clearing/Grubbing ☐ Gra	ding $\Box$ Trench	hing 🔲 Stringing/Weldir
☐ Lowering/Backfilling	☐ Final Grading ☐ Ten	np. Stabilization   Perm.	Stabilization   Dormant
			Yes No N/A
	rols installed and implemented in accordate control plan and stormwater manageme		and 🖂 🗆
Are all control measures properly maintained in effective operating condition in accordance with good engineering practices and, where applicable, manufacturer specifications?

## FIELD INSPECTION PHOTO LOG

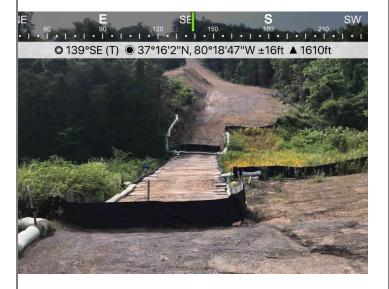
Figure 3. Designated stream S-G38, ECD's are in place.

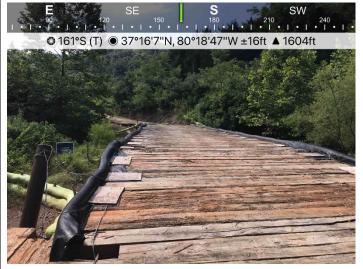
Figure 4: Designated stream S-G36 on AR 268.01
